Bowser derailment: a case report

Richard L. Allman, MD, MS

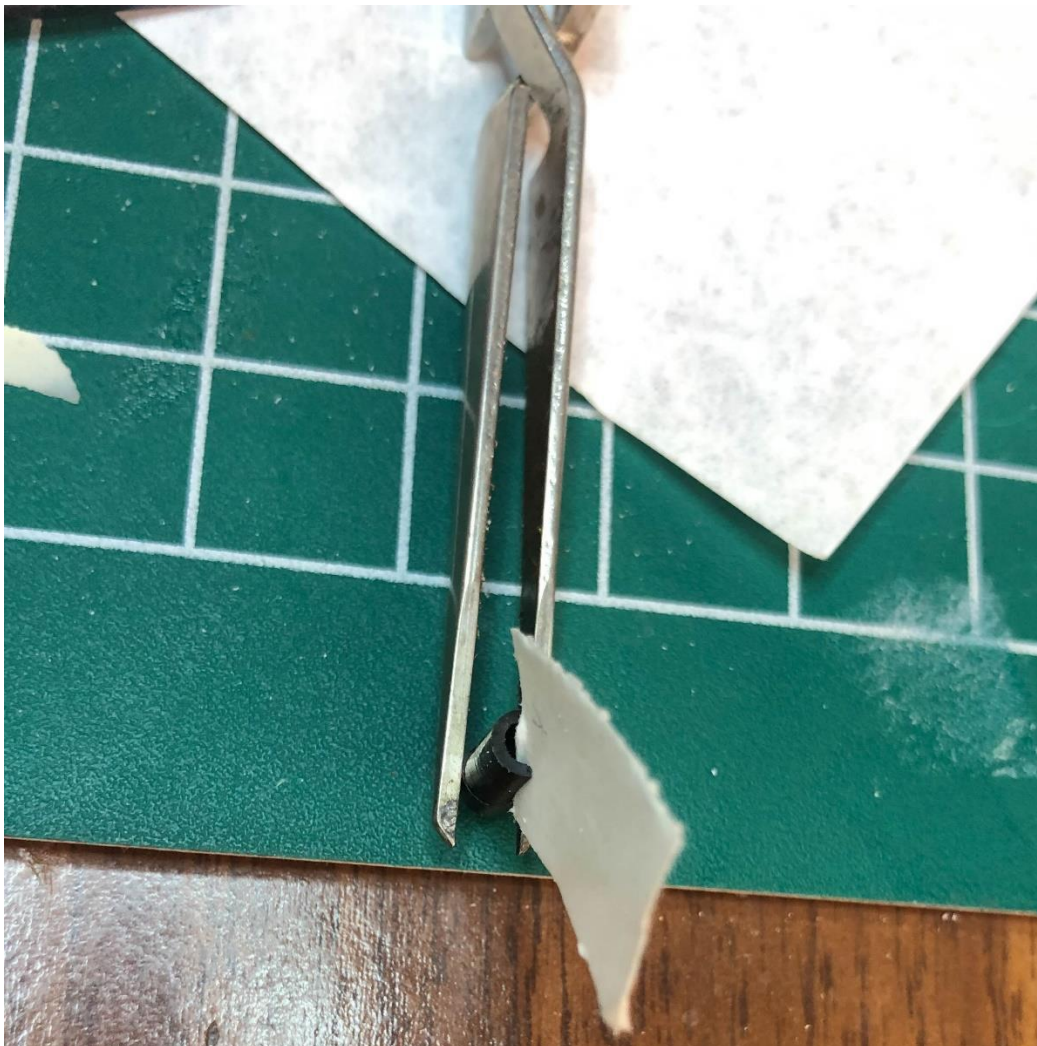
When the wheels and axles were removed, the first thing noticed was that one of the stub axles was no longer snugly held in the space sleeve that holds the wheel and axle set. A close look under magnification revealed that there was radial split in the sleeve, which made the wheel loose and unstable in the sleeve and easily out of gauge. Why the wheels don't turn when the plate is in place is uncertain. It might relate to the bulge created where the sleeve is split. When the errant sleeve was replaced, the problem was solved, and smooth operation restored.

Figure 1. A thin piece of styrene is in the radial break in the Bowser axle sleeve. Replace the sleeve and problem solved!

Solution: replace the split sleeve with new one.
